R-TR-77-013

## EVALUATION OF LUBRICATING COMPOSITES FOR THE M16A1 RIFLE

FEBRUARY 1976

GENERAL THOMAS J. RODMAN LABORATORY  
ROCK ISLAND ARSENAL  
ROCK ISLAND, ILLINOIS 61201

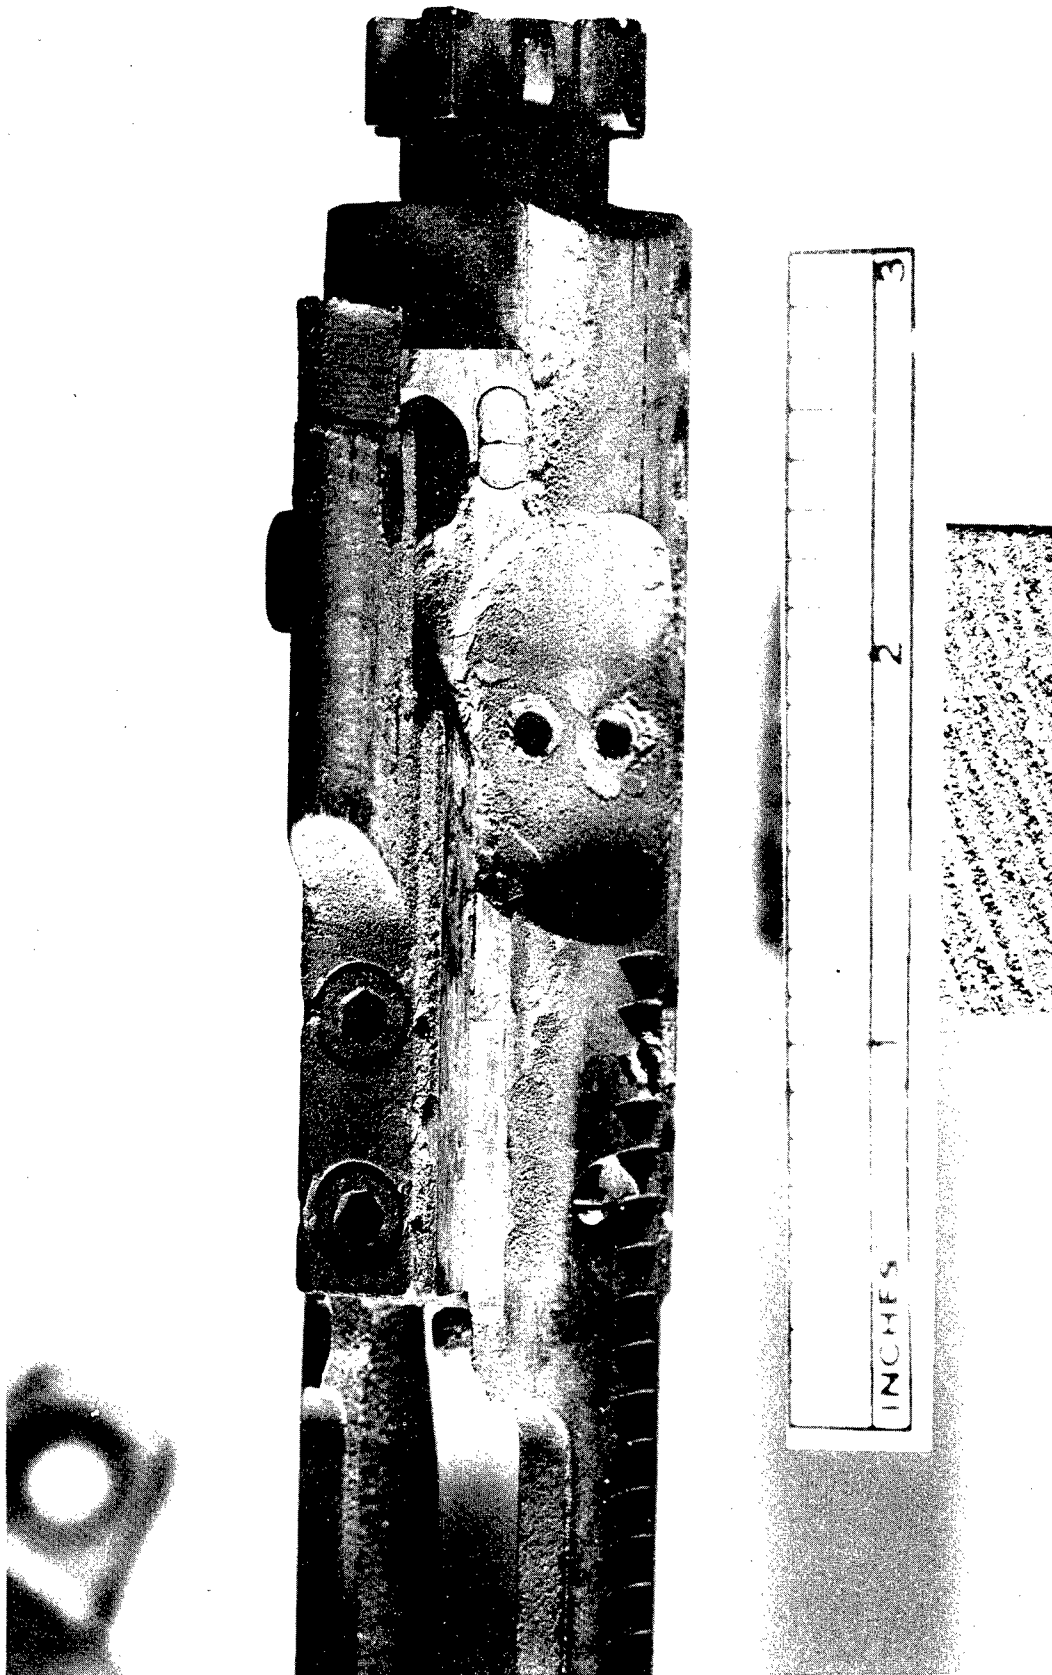
Although Rifles Nos. 2 and 3 completed the 10,000-round test, the composite insert in the cam path area had cracked. In Figure 9, the bolt carrier of Rifle No. 3 is shown at the end of the test with the cracked insert. Therefore, with the exception of Rifle No. 4, which was in the test for only a short time, the composite insert in the cam path area, at which the cam path wall was broken through during machining, either fell out or broke off, or was cracked. The effect of this on the test results is difficult to assess. The exact time at which these inserts cracked could not be determined; however this cracking could have occurred very early in the test. Some malfunctions undoubtedly occurred because of these cracked inserts and not because of any lubrication deficiencies. In spite of the difficulties encountered with the inserts in this one area of the carrier cam, the 6-malfunction rate per composite-lubricated rifle is considered very good.

This test shows that the self-lubricating composite does decrease the malfunction rate even though no cleaning or relubrication is carried out. The test also shows that the self-lubricating composite tends to be brittle and will crack if it is not properly placed or if it is not backed up with sufficient high-strength material.

Figure 9. Bolt Carrier after 10,000 Rounds Showing Cracked Insert.

2. Since the lubricating composite tends to be brittle and susceptible to cracking, care must be exercised in machining the insert holes and in placing the inserts.
